# **REPAIR AND STRENGTHENING OF HISTORIC MASONRY BUILDINGS IN SEISMIC AREAS**

D. PENAZZI<sup>1</sup>, M.R. VALLUZZI<sup>2</sup>, A. SAISI<sup>1</sup>, L. BINDA<sup>1</sup>, C. MODENA<sup>2</sup>

## **SUMMARY**

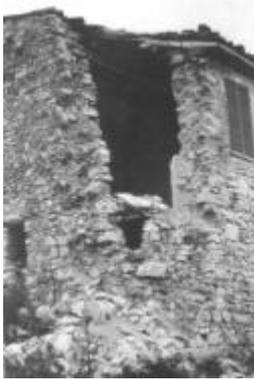
1. Out of plane of loadbearing walls with local or total collapse of the facades or of the corners, or large deformation of the walls. This mechanism is due to the lack of connection between orthogonal walls (Fig. 1) and between walls and floors or roofs (e.g absence of tie rods) and to the presence of large openings (Fig. 2).
2. Out of plane mechanisms with local or large failures of the upper part of the walls and collapses of parapets, cornices and spandrels. Large diffused cracks appear where beams are settled, and local collapses occur due to the high stresses caused by the hammering. Due to the thrust of the roof and to the absence of connection between the roof and the masonry (also due to the masonry heterogeneity) the detachment of concrete ring beams was also observed (Fig. 3).

Fig. 1: Failure of a building corner

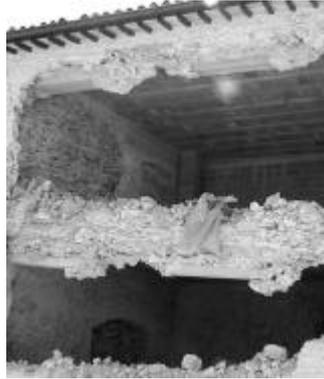
Fig. 2: Out of plane collapse of a bearing wall

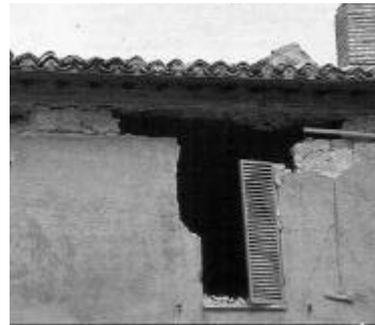
Fig. 3: Partial collapse due to the thrust of the roof and bad connection tie beam-wall

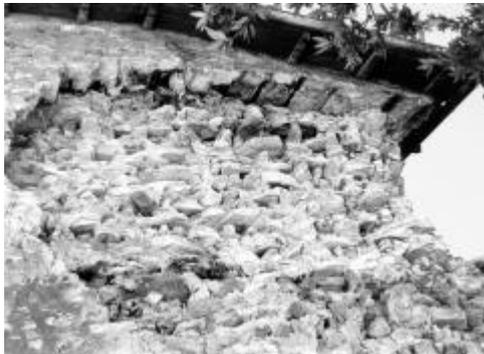
3. Wall disconnection and leaf separation with local or global failures. The presence of inhomogeneities in the wall, the lack of connection between the leaves of multiple leaf walls (Fig. 4), the filling of openings without good connection between the old and the new parts or the use of different types of materials can be the causes of such mechanism.
4. In plane mechanisms due to shear stresses with diagonal cracks of piers and walls at the different floors. They are mainly due to: bad positioned openings, differential stiffness of the walls between openings, presence of weak lintels (Fig. 5).

Fig. 4: Separation of the two leaves of a wall

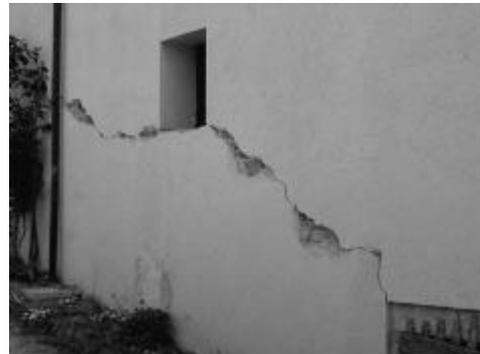
Fig. 5: Shear failure of a wall

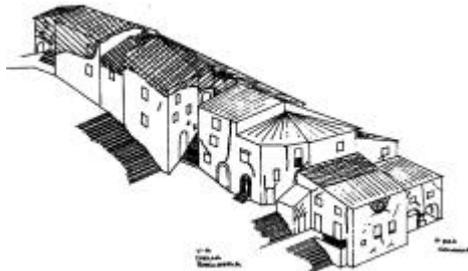
In all the blocks, the first and the last building are badly damaged by local collapses and large cracks (Fig. 6). When the collapses occur in the internal part of the blocks they always interest the non repaired buildings adjacent to the repaired ones (Fig. 7). In the central part of the building curtains with the presence of decayed floors and roofs large continuous deformations and out of plumb of the walls were detected. Moreover, due to the hammering of the two blocks cracks and damages appear where vaulted passages connect two blocks of buildings . This phenomenon is more clear when only one of the blocks was repaired.

Fig. 6: Failures of end buildings in a row

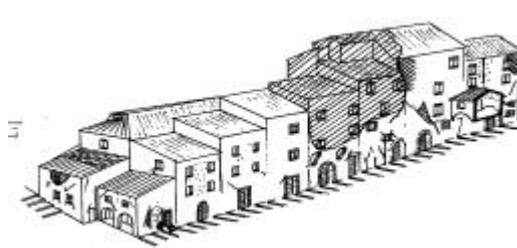
Fig. 7: Failure of center non repaired buildings in a row

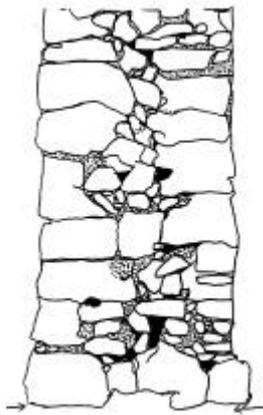
Fig. 8 Poor section with very low content of voids

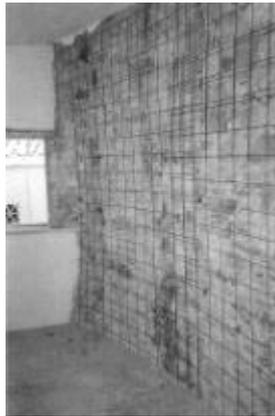
Fig. 9 Lack of connection between nets

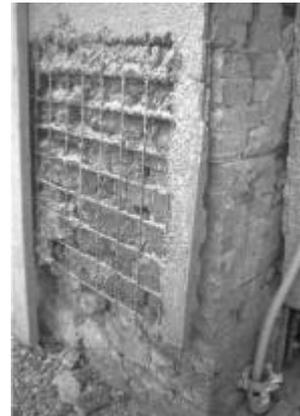
Fig. 10 Lack of connectors

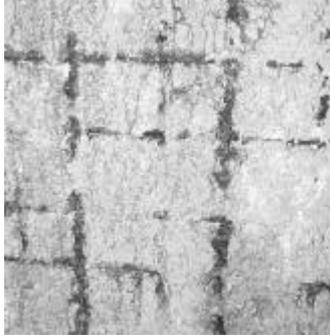
Fig. 11 Corrosion of the net

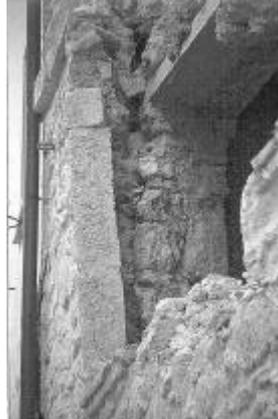
Fig. 12 Eccentric loading to concrete tie positioning

thickness of the top wall, whereas at each floor it can only be inserted in part of the section, after partial demolition of that. Therefore, it is very difficult to release a stiff connection to the existing wall, especially when the wall is made of a multiple leaf irregular stone masonry. The damage observed more frequently were the following: (i) partial eccentric loading of the walls (Fig. 12), (ii) lack or poor connection of the tie beam to the walls .
