HISTORIC MASONRY RESTORATION

Through the Eyes of a Master Stonemason

By Mark Mendel

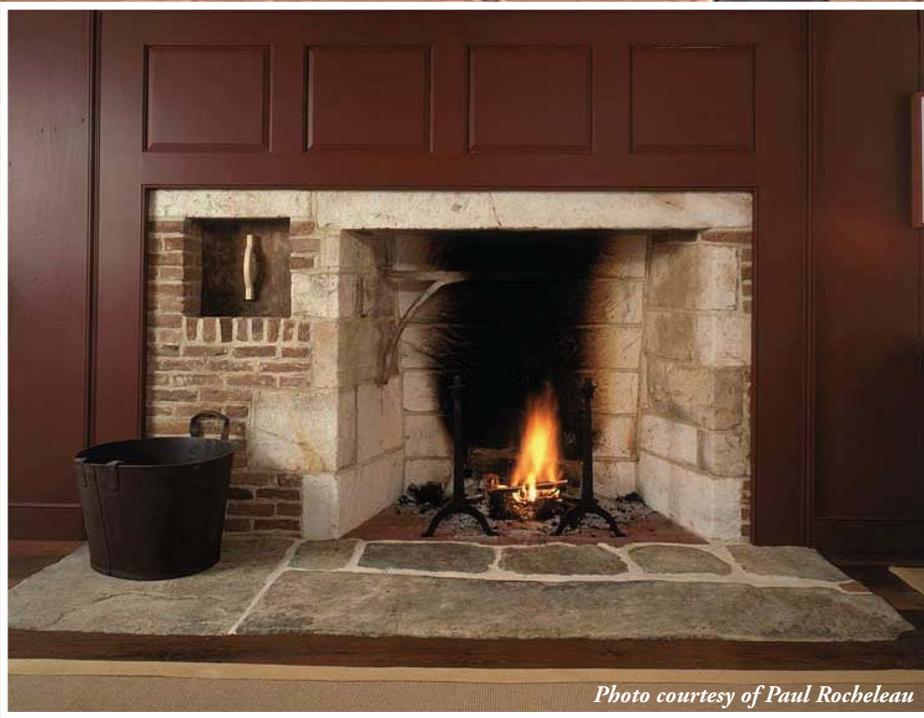
Restored 18th century fireplace and bake oven. Marble cheeks, brick, granite hearthstones.

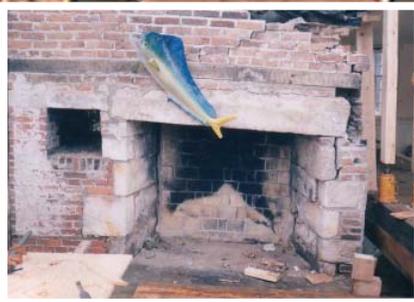
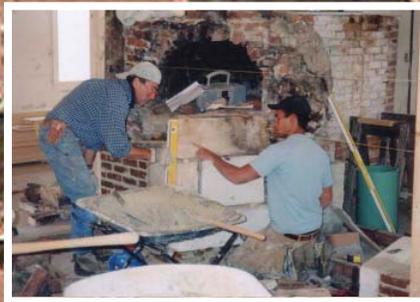
18th century fireplace and bake oven before and during restoration.

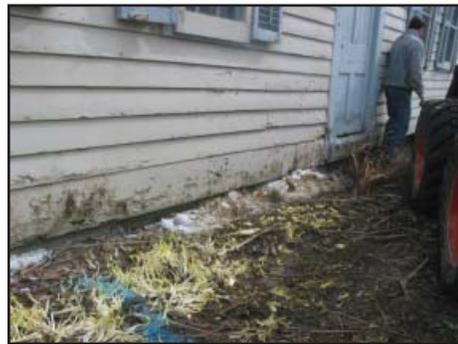
18th century village house. Grade has gone up and sills are rotted.

1. Wooden sills rotting from sustained moisture.

The Sills of old houses were typically resting, 16 to 20 inches above grade, high and dry upon a brick or stone foundation wall or upon split granite "set up" stones. Now we see old houses that appear to have sunk into the ground with their bottom most clapboards at grade. In the 19th century, it became fashionable to surround a house with a necklace of shrubs. As the decades passed, the annual fallen and composted leaves caused gradual rise in the grade. The house never sank, but it might as well have for now the sills lie beneath the snow. The solution, after the sills have been repaired, is to remove the shrubbery and return to the original grade that must be pitched to drain away from the house.

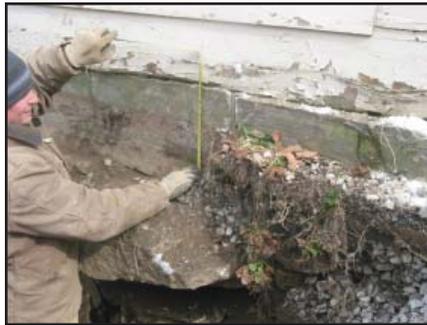
18th century village house showing original stones “sunken” below grade.

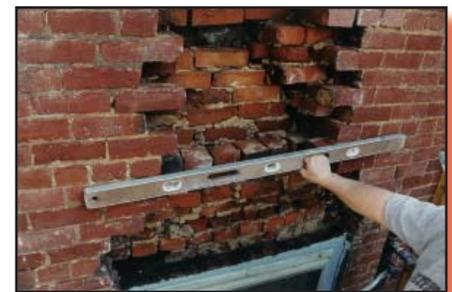
Detail showing original brick coursing “off” by one course.

When his brickwork came around the house, he was one course off. That's about 2 ¾ inches. Hard to hide, but also hard to fix. So somebody decided to leave the mistake. Just have the carpenters make crooked windows. Make them about 2-¾ inches out of square. We decided not to correct this situation... it has been structurally sound for 150 or so years.

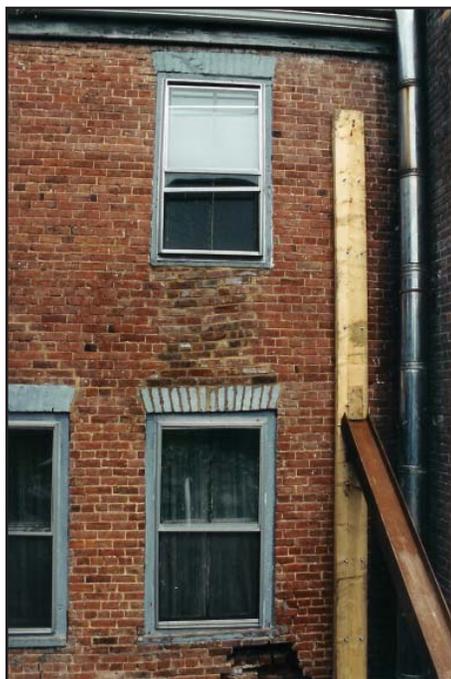
Finished job with original mistakes left in.

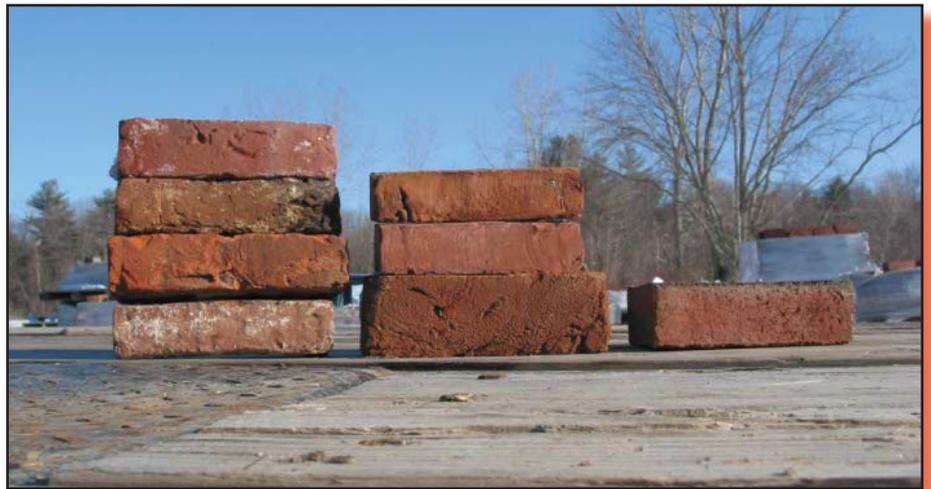
Left to right: hand made 18th century brick, restoration brick, new wire cut brick.

18th and early 19th century bricks were hand made locally, if not on site. In New England, bricks were typically 7 to 8 inches long, 1-1/2 to 2 inches high and 4 inches wide. They were thinner than modern brick, which are typically 2-5/8 inches high. Bricks were not perfectly copacetic as are today’s industrially produced wire cut brick, but had a rather wide range of unique shapes and colors. With their shapeliness and no-two-bricks-alike qualities, they resembled the product of the potter’s kiln. They had a soft beauty that contemporary large-scale manufacturers cannot match. Even if bricks of modern manufacture are sawn or special ordered to size, their monotonous flatness stands out as a glaring patch in any restoration.

- Allow *time* in the planning process to source out matching brick. If substituting new restoration brick, use brick that is *manufactured* in the old way, not just new brick that has been decorated to look “antique”. Yes, there are companies that still press clay into wooden molds as in the old days. They produce beautiful brick that meet modern specs but match antique brick perfectly. They can also do a great job of custom matching site specific original brick. Allow time in planning. These companies may not be as fast with an order, but the results cannot be compared with off the shelf brick. Three companies that make these brick are Vermont Brick, Morin Brick in Maine, and Old Carolina Brick in North Carolina.

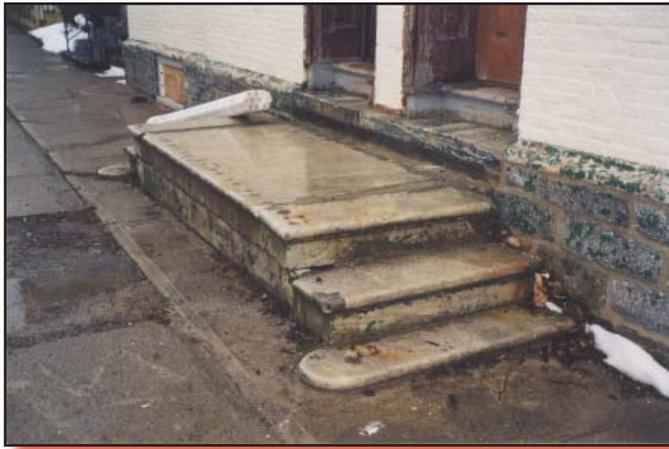
1803 townhouse. Marble entry in disrepair. Note concrete sidewalk has risen 8" from original grade burying bottom step

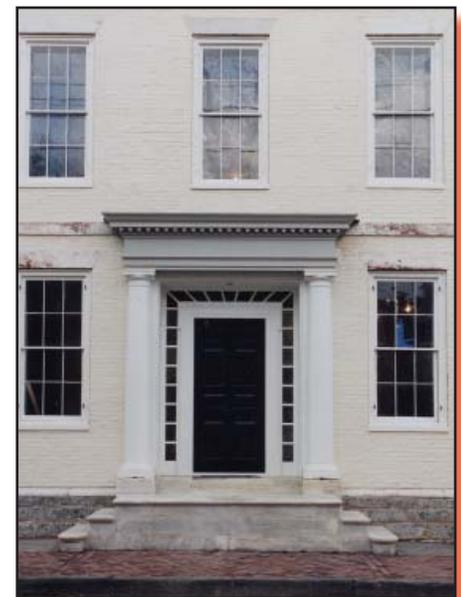
1803 townhouse with marble repaired and relayed on proper foundation. Entry restored to single doorway. Concrete sidewalk replaced with 19th century brick pavers.
